CERAMIC GAS TURBINE ENGINE DEMONSTRATION PROGRAM

Final Report, January 1976 to May 1981

Prepared under Contract Number N00024-76-C-5352

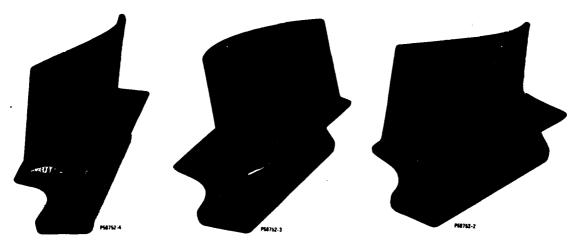
Figure 5-17. Machining Damage on HPSN Rotor Blades Detected by Dye Penetrant Inspection.

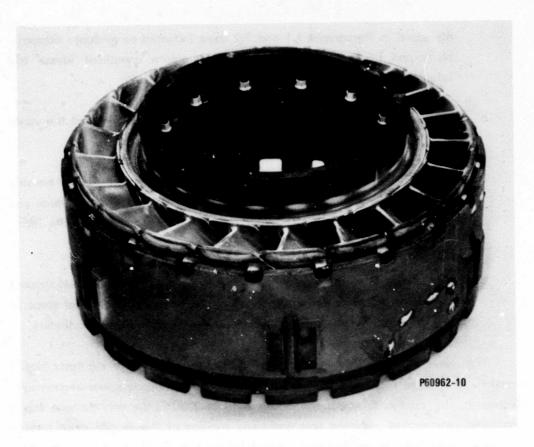
Figure 6-3. Ceramic Assembly After First-Stage Stator Static Rig Test No. Nine to Design Aerodynamic Loading at 2200°F.

The above modifications were evaluated in first-stage stator rig tests Nos. 5 through 9.8,9 The incidence of damage to ceramic components was sequentially decreased. In test No. 9, run at the design point of 2200°F, the only damage was a fractured rear shroud retaining ring and some spalling of the second-stage turbine shroud. The spalling was caused by a silicon-rich core in the RBSN shroud, requiring processing improvement at the vendor and a modified certification procedure. The ceramic assembly after test No. 9 is shown in Figure 6-3.

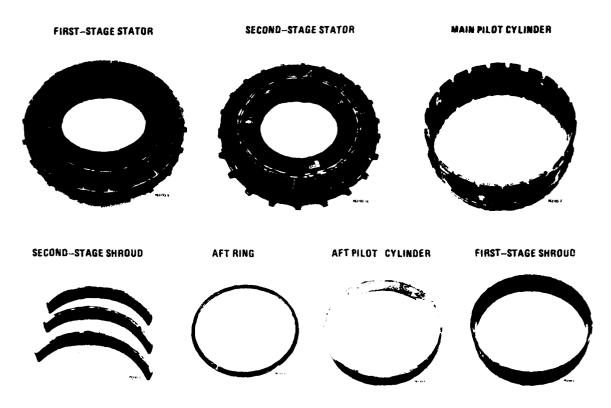
Figure 6-5. Ceramic Components After 10 Hours (2 Light-Offs, 22 Transient Cycles) Two-Stage Static Rig Testing to 1750°F Average Inlet Temperature and 120 Percent Design Aerodynamic Loading.

The shaft assembly prevented reaching 120 percent design aerodynamic loads in the second test. The rig for the third test was rebuilt without the shaft assembly and operated at 1750°F, 145 psia and 6 lb/sec. for 10 hours. The test included two lightoffs and 22 cycles from 1250-1750°F at a transient rate of 250-350°F/sec. As shown in Figure 6-5, all ceramic hardware survived without damage.

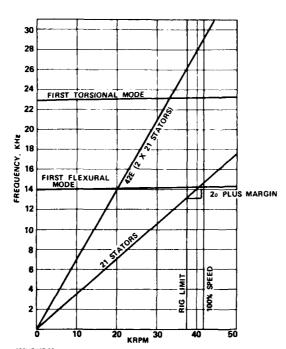
Figure 6-6. Second-Stage Rotor Blade Vibration
Diagram for the First Dynamic
Rig Test,

a maximum speed of 90 percent (37,500 rpm). This speed limit of 90 percent was selected to avoid blade resonance with stator passing frequency, which was based on the predicted second-stage blade excitation diagram, Figure 6-6. This rig limit of 90-percent speed provided a margin greater than two standard deviations. Based on the rig and blade analysis, it was judged that the ambient rig test to 90-percent speed would be an adequate system checkout with little risk.

After one hour of total rig time and approximately 60 seconds into a slow acceleration from 36,000 rpm to 37,000 rpm, a distinct "pop" was heard from the test cell, and the rig immediately coasted down to zero rpm. Shutdown was carried out, and the rig tailpipe was then removed for a visual inspection of the ceramic blades. It was observed that one blade had fractured in the attachment, and all others suffered airfoil damage (Figure 6-7). A comparison of speed and vibration traces showed that the change in vibration and the deceleration were coincident.

Visual inspection showed that one blade had a smooth fracture (shown previously in Figure 4-15 in Paragraph 4.1.8) below the platform adjacent to the contact zone, but not at the position analytically predicted to have the peak stress. As described in Paragraph 4.1.8, the fracture surface was different from any encountered previously in bend testing, tensile testing, thermal shock testing, impact testing or blade proof testing. The remaining blades all had jagged fracture surfaces above the platforms and appeared to have failed because of impact. The metallic second-stage turbine tip shroud had a single, well-formed blade indentation. The visual evidence thus suggested that one blade fractured for unknown reasons below the platform, hit the tip shroud and then impacted the other blades.

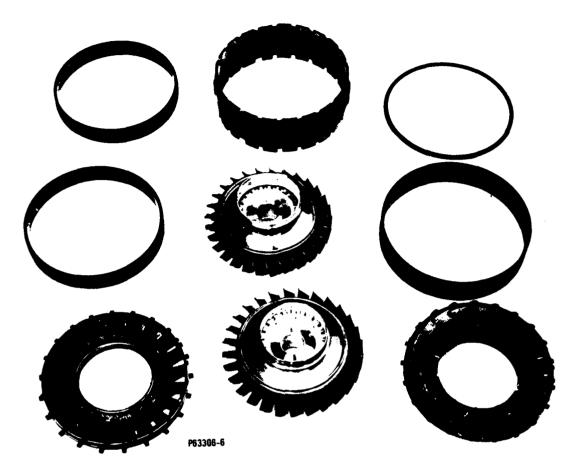
Figure 6-11. Ceramic Components After Accumulation of 20 Hours and 23 Light-Offs in Engine Tests Four Through Thirteen.

Test No. 11 consisted of two one-hour cycles to 31,000 rpm. During both lightoffs, the peak TIT during the start transient was under 1700°F. All ceramic hardware was in excellent condition and was acceptable for further testing. This hardware subsequently survived five one-hour cycles in engine test No. 12 and five two-hour cycles in engine test No. 13, bringing the total engine time to about 20 hours and 23 lightoffs. The ceramic hardware after this testing is illustrated in Figure 6-11.

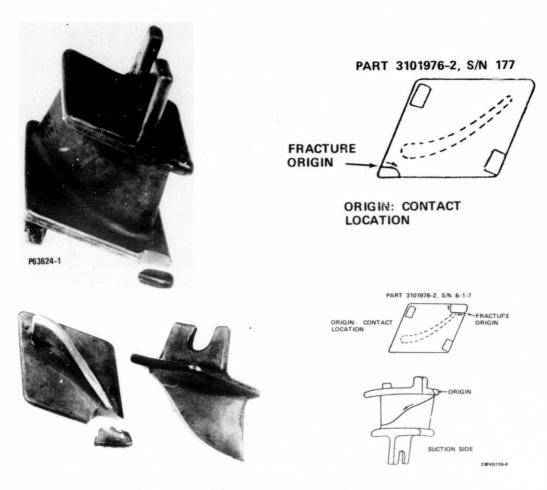
Although the TSE331C-I engine could be operated with no apparent problems for a single cycle, problems arose during multi-cycle, transient operation. Chipping and cracking occurred at several ceramic-ceramic static structure interfaces and in several cases resulted in engine failure. A variety of minor design modifications such as changes in contact contour and utilization of compliant metallic interface layers were not consistently effective. Near the end of the program, engine testing was suspended, and all program resources were concentrated on achieving an understanding of the mechanism of interface damage and in developing a solution.

Figure 6-12. Contact-Initiated Damage on Two Stator Vanes From Engine Test 14.

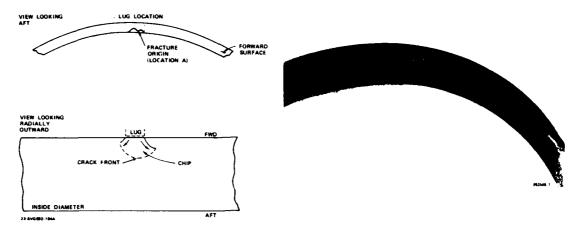
Figure 6-14. Photograph and Schematic Showing the Position and Orientation of the Small Crack on the First-Stage Tip Shroud.

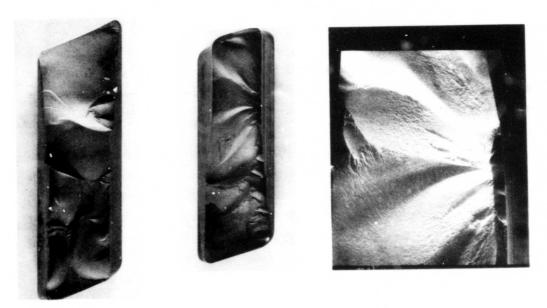
Figure 6-15. SEM Photomicrographs Showing the Fractured Surfaces of Blades that Fractured Below the Platform in Test 17 of Engine CE001.

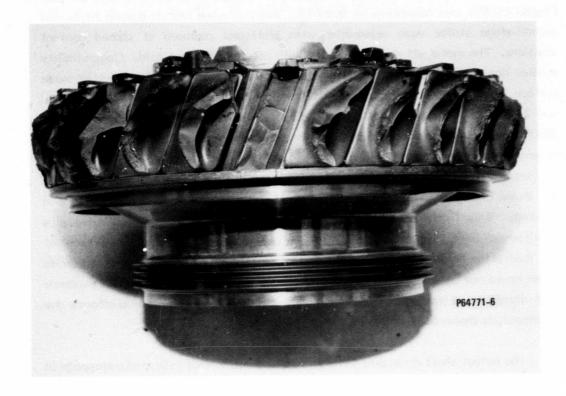
Figure 6-16. First-Stage Rotor After Engine Test CE001-17 Showing One Blade Fractured Below the Platform and the Rest Fractured by Impact Above the Platform.

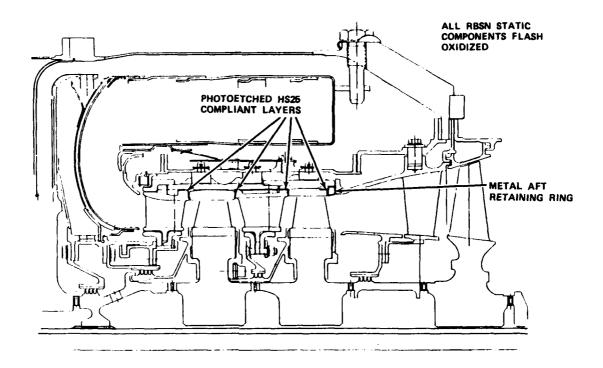
Figure 6-17. Engine Configuration for CEGO2 Test No. 8.

Test 8 consisted of a standard 2-hour cycle to full design conditions of 41,730 rpm and 2200°F. The test was run and shut down without incident. Disassembly revealed all ceramic components to be in the proper position, but several were damaged. A wedge-shape section was missing from the trailing edge of a first-stage stator vane. The fracture origin indicated the cause of fracture to be impact. Minor chipping or surface roughening type impact damage was present on 90 percent of the first-stage vanes and 30 percent of the second-stage vanes. No witness marks due to foreign materials were visible or detected by EDX analysis, suggesting that Si₃N₄ was the likely impacting material.

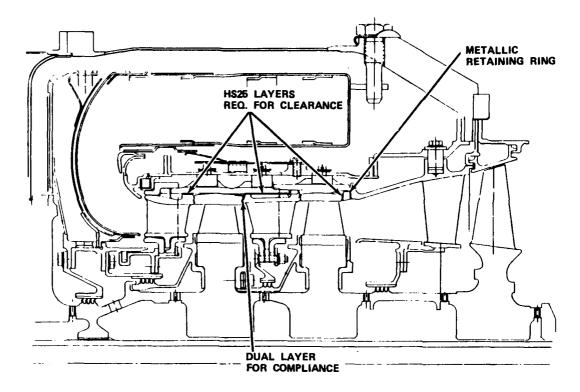
Engine light-off for Test CE 002-10 was accomplished smoothly, and acceleration to idle occurred without incident. Ten minutes were spent at idle followed by an acceleration to 100-percent speed and 1400°F T_4 . Eighty minutes were spent at this condition followed by 6 hours 40 minutes at 1700°F T_4 . A slow transient to 2200°F was then performed. After running 11 minutes at 2200°F, an engine failure occurred.

Ail ceramic parts except the first-stage inner support rings fractured into many small pieces. No blades were fractured below the platforms, suggesting that engine failure was not initiated by blade failure. However, all other parts were too fragmented to identify the source of initial fracture or to determine where in the engine test cycle the first damage initiated.

Figure 6-18. Compliant Layer Positions for Engine Test CE002-10.

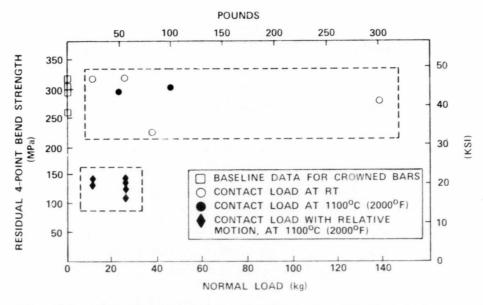
Results of initial testing of bare RBSN with and without relative motion for the point load condition* (0.25 inch radius crown on crown) are summarized in Figure 7-3. No surface damage was detected after static contact loads up to 308 lbs. The range in strength of these bars was the same as crowned baseline bars that had not been subjected to a static load (approximately 45 ksi). Most of the fracture origins were not located at the contact point.

Figure 7-3. Effect on Strength of Normal Contact Load (with and without Simultaneous Relative Motion).

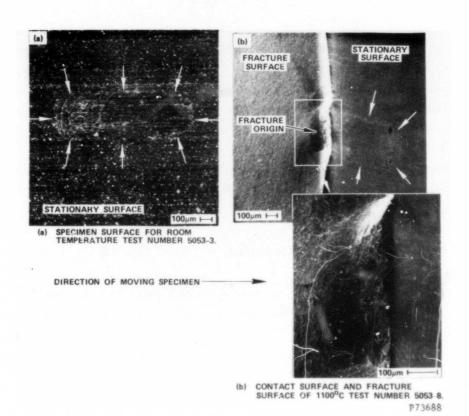
Figure 7-4. SEM Photomicrographs of Reaction-Bonded Si₃N₄ Stationary Test Bars After Contact Testing, Regions of Contact Outlined with Arrows.

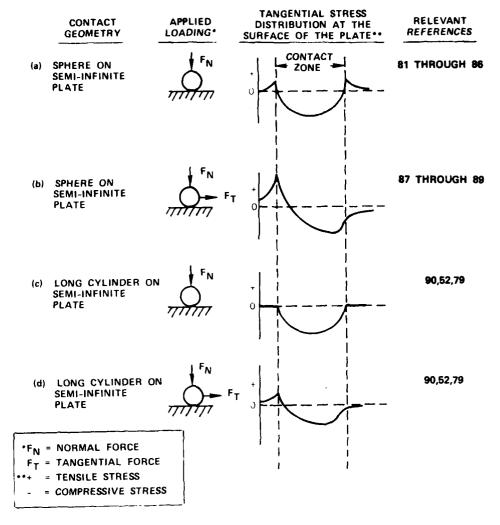
A literature search and experimental studies under this program ^{17,75} and a literature search plus analytical studies under a parallel ONR program ^{52,79} have identified the probable source of contact damage in the TSE331C-1 ceramic demonstration engine. Stress distributions for various load configurations are shown in Figure 7-5.

Figure 7-5a was initially analyzed by Hertz^{81} and is commonly referred to as $\mathrm{Hertzian}$ loading. The symmetrical stress field is compressive directly under the contact zone and tensile adjacent to the contact zone. The tensile stress peaks at

Figure 7-5. Contact Stress Distributions (Determined Analytically, Assuming Elastic Conditions) for Simple Contact Geometries for Normal and Biaxial Loading.

the edge of the circular contact zone and decreases with distance away from the contact zone. ⁸² Fracture initiates when the tensile stress becomes high enough to cause propagation of an existing material flaw at or near the surface adjacent to the contact zone. The crack initially forms a ring concentric with the contact zone. As the normal force is increased, the crack penetrates to greater depth following the stress contour in an outward sloping cone. ^{84–86}

The stress distribution for normal loading of a cylinder on a semi-infinite plate (Figure 7-5c) is similar to Hertzian loading except that no hoop tensile stress is present adjacent to the contact zone. Thus, under ideal contact, the contact stresses for a long cylinder on a plate will be compressive. However, for a short cylinder or for realistic conditions where surface asperities prevent ideal contact, localized tensile stresses are likely to be present.

Figures 7-5b and 7-5d show the stress distributions when a tangential force is present in addition to a normal force. The stress distribution is skewed to produce a sharp tensile stress spike on the material surface at the trailing edge of the contact zone. The tensile spike for this biaxial loading is of much higher magnitude than the tensile stress in Hertzian loading (for a given normal force) and thus results in material surface damage at a much lower normal load.

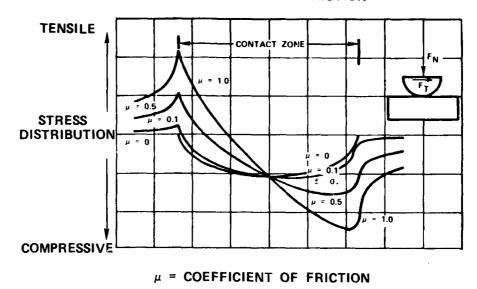
The magnitude of the tensile stress for sliding contact or biaxial loading is strongly dependent upon the coefficient of friction as shown in Figure 7-6. 52 The tensile stress is very localized, peaking at the surface at the trailing edge of the contact and rapidly diminishing beneath the surface. 52

Figure 7-6 Effect of Friction on Stress Distribution for Biaxial Contact Loading.

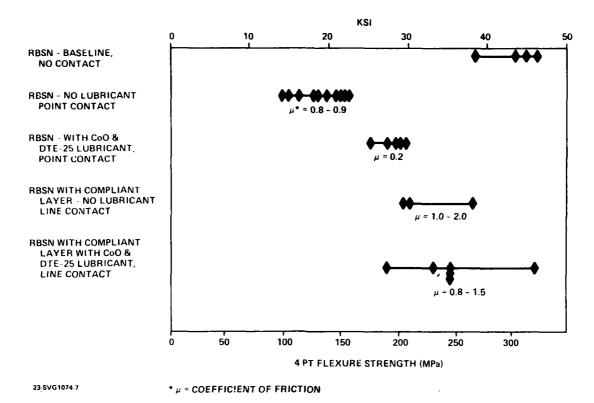
Figure 7-10. Retained Strength and Friction-Comparison for Bare RBSN, Lubricated RBSN and HS25 Metal Compliant Layer.

Use of pre-oxidized HS25 resulted in less chipping and strength degradation of the RBSN. As shown in Figure 7-10 strengths were in the 30 to 40 ksi range 182
